INTERNAL AUDIT DIVISION

REPORT 2018/007

Audit of post-construction and occupancy of the new office facility for the Mechanism for International Criminal Tribunals at Arusha

19 February 2018
Assignment No. AA2017/261/07

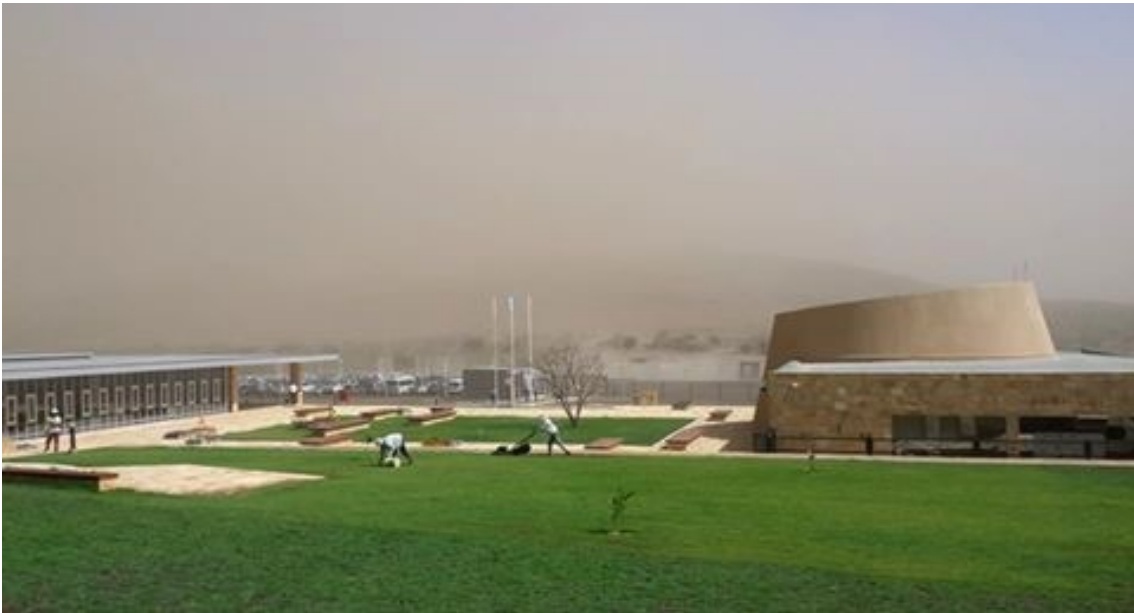
44. The current Office Building in Arusha has a ventilated roof and louvre windows designed to enable free circulation of natural air. However, during sandstorms, dust fills the rooms and some staff members have to wear dust masks to cope. At the time of audit, at least two staff members were reportedly taken ill as a direct consequence of sandstorms. Also, sandstorms have left the roof vulnerable

Photo 2: View of an approaching sandstorm behind the Court and Archive Buildings

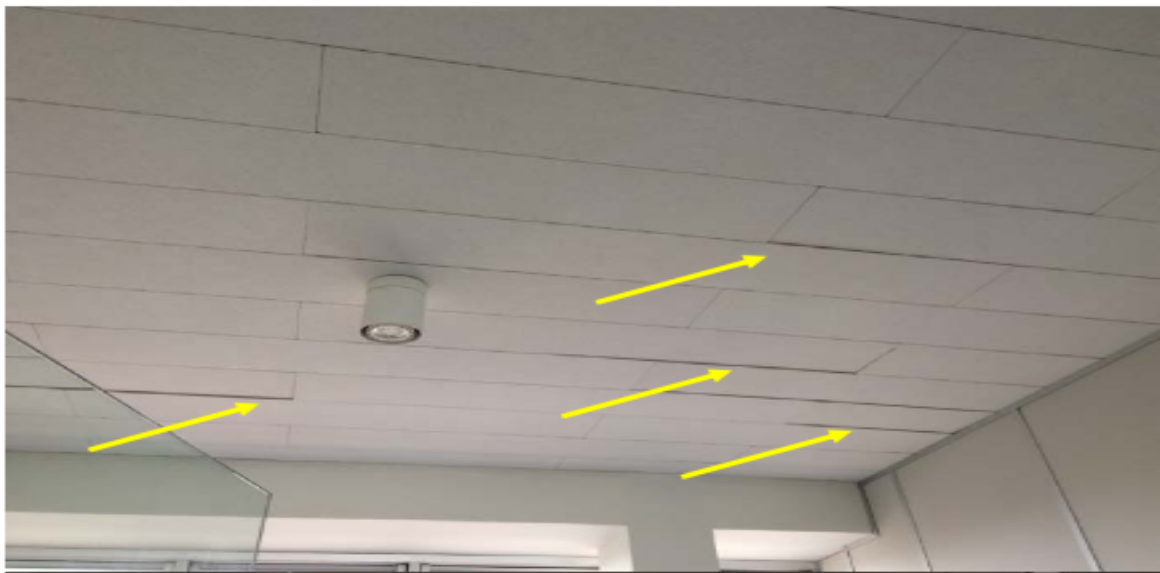
as the ceiling shakes when the sandstorms occur (see Photo 3 below) to the extent that a ceiling block fell directly on the seat of a staff member in a documented incident earlier in 2017. Fortunately, the staff member was not at the desk at the time.

Photo 3: Shaky ceiling due to the impact of a sandstorm

(5) MICT should: (i) in consultation with the Office of Central Support Services, investigate the impact of sandstorms on the Office Building and take appropriate remedial action to address it [REDACTED]

MICT accepted recommendation 5 and stated that it is currently working on options to address the sand infiltration through the attic louvers. Once the design and specification for remediation works are completed, the works will be executed subject to the availability of funds. [REDACTED]
