INTERNAL AUDIT DIVISION

REPORT 2018/007

Audit of post-construction and occupancy of the new office facility for the Mechanism for International Criminal Tribunals at Arusha

19 February 2018
Assignment No. AA2017/261/07

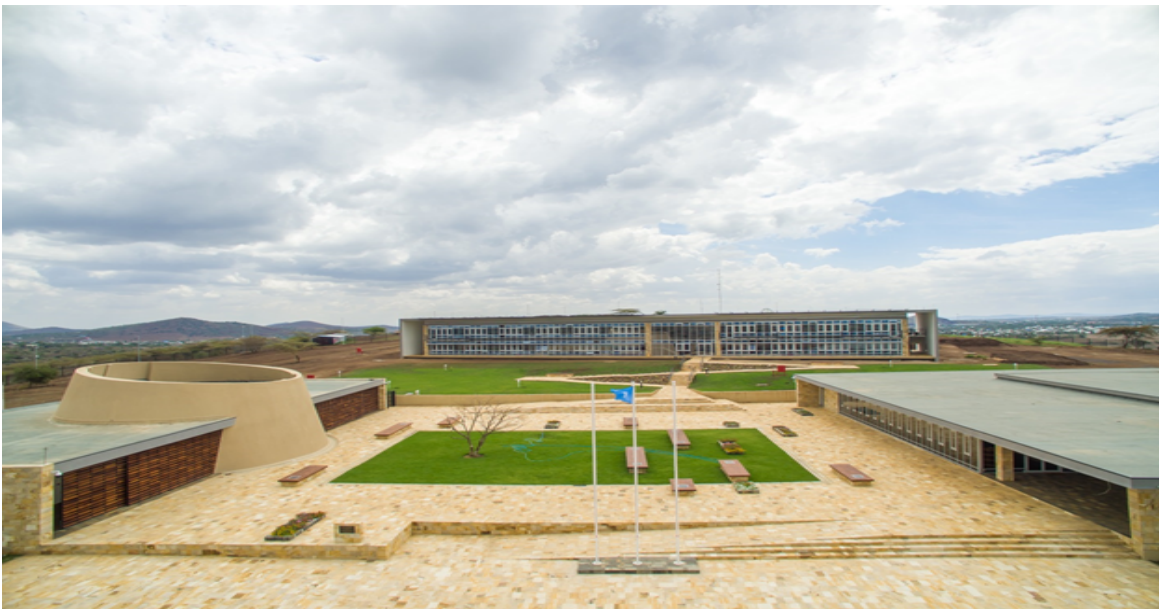
Photo 1: View of the new office facility at Lakilaki, Arusha

13. The construction of the new office facility at MICT Arusha was declared substantially completed on 1 December 2016, within budget. This was attributed, among others, to effective project management, cooperation of multiple stakeholders, the governance framework (with input from OCSS, PD, OLA and other offices at the United Nations Headquarters), maximization of local resources and materials, substantial application of lessons learned from other United Nations projects, and the creation of new best practices. MICT substantially relocated from rented offices to the new office facility on 5 December 2016 except for the archives which remain at the rented premises. Photo 1 above shows the completed office facility.
